**Flood Control Project Maintenance  
Levee Inspections**  
**LMA District Cover Sheet**  
**Spring 2017 Levee Inspection Results**

**Sacramento Maintenance Yard Maintenance Area 0009**

Waterway			Bank	Unit Miles
Unit No. 01 Sacramento River			Left	19.35
	Spring (March - May)	Summer (June - August)	(September - November) Fall	Winter (December - February)
Unit Maintenance Rating (Fall Only)				
Date of Inspection	4/25/2017 - 4/26/2017			
DWR Inspector	Zach Jojola			
Accompanied By	Dave Williams Sacramento Maintenance Yard

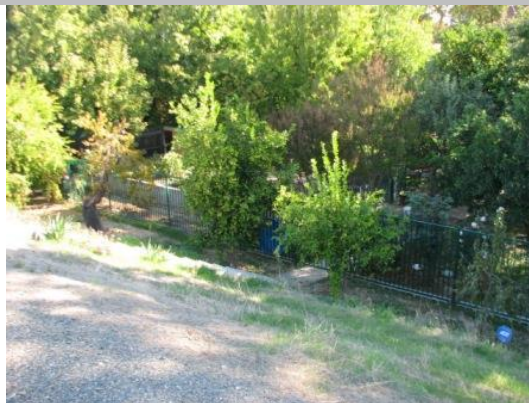
Photo 1 of 2 : SP\_2017\_MA0009\_201\_97\_20170320\_00064.jpg

LM Start	4.03	Rating **	M	Issue No.	97
LM End	4.03	Issue Type +	En	Location *	LS
Category	Earthen Levee			GPS Latitude/Longitude	
				Start	End
Item	Vegetation			38.509127 °	38.509127 °
				-121.554353 °	-121.554353 °
DWR ID	DWR_MA0009_01_f_2013_97				
Comment Code					
V6 : Landscaping					
Inspector Comment					
Fruit trees are at the toe of the levee.

Fruit trees and landscaping within the easement. Fall 2013

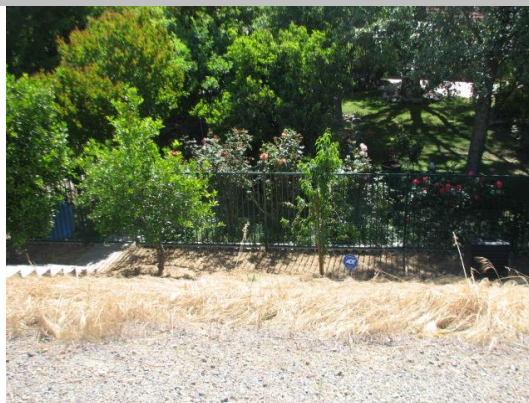
Photo 2 of 2 : SP\_2017\_MA0009\_201\_97\_20170320\_00065.jpg

New fruit trees have been added to the toe of the levee. Spring 2014

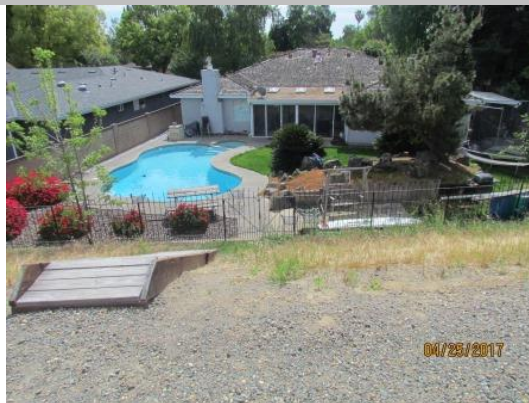
Photo 1 of 1 : SP\_2017\_MA0009\_201\_105\_20170426\_00502.jpg

LM Start	4.06	Rating **	M	Issue No.	105
LM End	4.06	Issue Type +	En	Location *	LS
Category	Earthen Levee			GPS Latitude/Longitude	
				Start	End
Item	Encroachments			38.508666 °	38.508666 °
				-121.554584 °	-121.554584 °
DWR ID	DWR_MA0009_01_s_2012_105				
Comment Code					
ST : Stairway					
Inspector Comment					
Steps, fence, and pool do not appear to be permitted.

View of steps, fence and landscape. Spring 2017

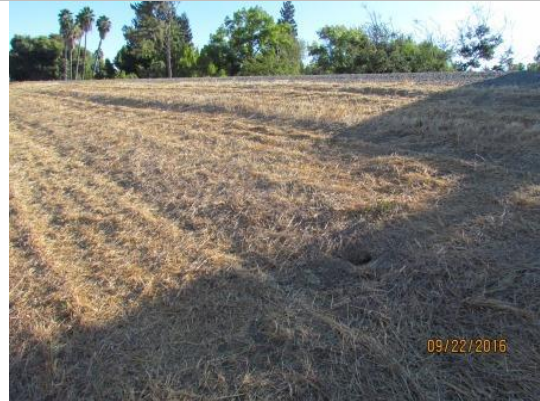
Photo 1 of 1 : SP\_2017\_MA0009\_201\_326\_20170320\_00246.jpg

LM Start	4.07	Rating **	M	Issue No.	326
LM End	4.07	Issue Type +	Ma	Location *	WS
Category	Earthen Levee			GPS Latitude/Longitude	
				Start	End
Item	Animal Control			38.508478 °	38.508478 °
				-121.554705 °	-121.554705 °
DWR ID	DWR_MA0009_01_f _ 2015_326				
Comment Code					
A3 : No rodents visible, but rodent burrows visible; need to backfill and compact or grout burrows.					
Inspector Comment

Rodent hole at WS slope. Fall 2016.

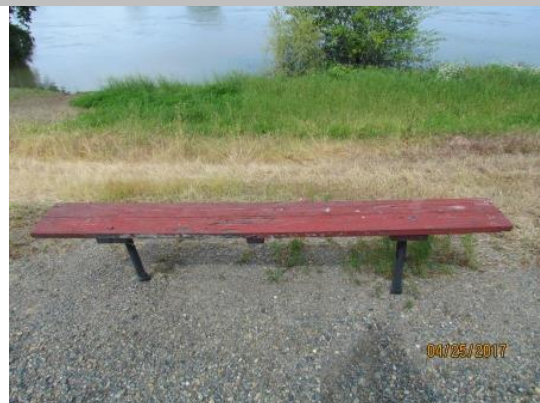
Photo 1 of 1 : SP\_2017\_MA0009\_201\_274\_20170426\_00503.jpg

LM Start	4.09	Rating **	M	Issue No.	274
LM End	4.09	Issue Type +	En	Location *	WS
Category	Earthen Levee			GPS Latitude/Longitude	
				Start	End
Item	Encroachments			38.508315 °	38.508315 °
				-121.554740 °	-121.554740 °
DWR ID	DWR_MA0009_01_s_2017_274				
Comment Code					
DE : Debris					
Inspector Comment					
Bench on waterside shoulder.

View of bench on waterside shoulder. Spring 2017.

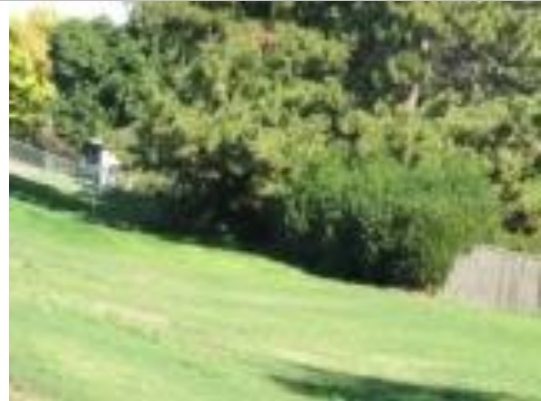
Photo 1 of 2 : SP\_2017\_MA0009\_201\_108\_20170320\_00072.jpg

LM Start	4.14	Rating **	M	Issue No.	108
LM End	4.15	Issue Type +	En	Location *	LS
Category	Earthen Levee			GPS Latitude/Longitude	
				Start	End
Item	Encroachments			38.507632 °	38.507409 °
				-121.555157 °	-121.555302 °
DWR ID	DWR_MA0009_01_s_2012_108				
Comment Code					
FE : Fence					
Inspector Comment

Fenced area with a walk through to the neighborhood. This is the City of Sacramento's property.

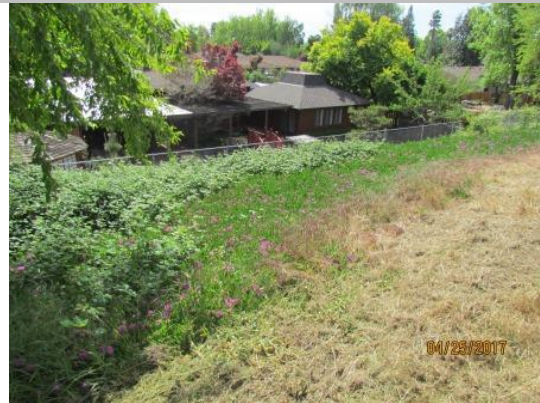
Photo 1 of 1 : SP\_2017\_MA0009\_201\_277\_20170426\_00504.jpg

LM Start	4.27	Rating **	U	Issue No.	277
LM End	4.27	Issue Type +	En	Location *	LS
Category	Earthen Levee			GPS Latitude/Longitude	
				Start	End
Item	Vegetation			38.505834 °	38.505834 °
				-121.555995 °	-121.555995 °
DWR ID	DWR_MA0009_01_s_2017_277				
Comment Code					
V6 : Landscaping					
Inspector Comment

View of vegetation on landside slope. Spring 2017.

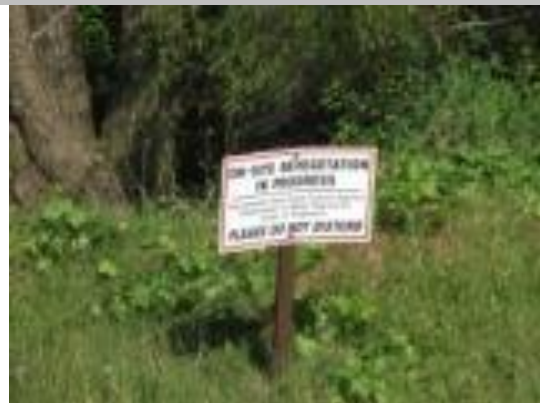
Photo 1 of 1 : SP\_2017\_MA0009\_201\_107\_20170320\_00071.jpg

LM Start	4.27	Rating **	A/W	Issue No.	107
LM End	4.36	Issue Type +	En	Location *	WS
Category	Earthen Levee			GPS Latitude/Longitude	
				Start	End
Item	Vegetation			38.505824 °	38.504553 °
				-121.555998 °	-121.556423 °
DWR ID	DWR_MA0009_01_s_2012_107				
Comment Code					
V8 : Environmental Requirements.					
Inspector Comment

A revegetation site. Photo taken spring 2012.

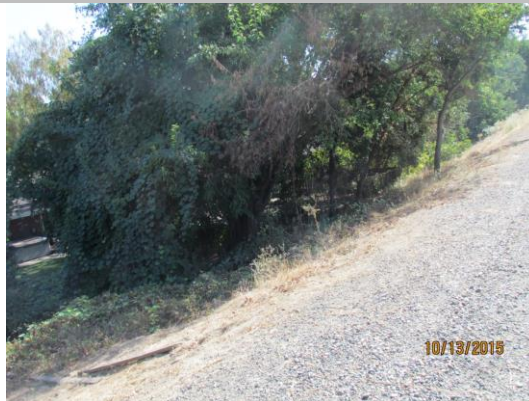
Photo 1 of 2 : SP\_2017\_MA0009\_201\_335\_20170320\_00254.jpg

LM Start	4.29	Rating **	M	Issue No.	335
LM End	4.29	Issue Type +	En	Location *	LS
Category	Earthen Levee			GPS Latitude/Longitude	
				Start	End
Item	Vegetation			38.505582 °	38.505582 °
				-121.556098 °	-121.556098 °
DWR ID	DWR_MA0009_01_f_2013_335				
Comment Code					
V6 : Landscaping					
Inspector Comment					
Vines on fence need to be monitored and maintained for visibility.

View of the vegetation on the landward side of the levee looking downstream. Fall 2015.

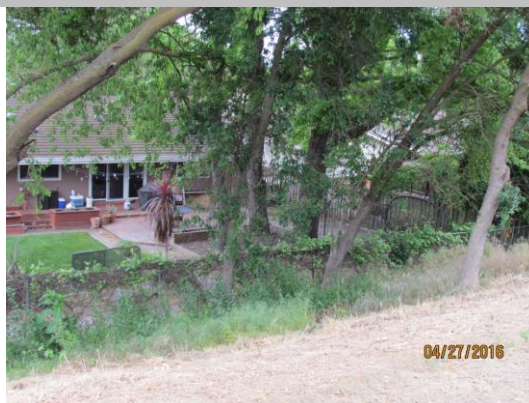
Photo 2 of 2 : SP\_2017\_MA0009\_201\_335\_20170320\_00255.jpg

View of the vegetation on the landward side of the levee. Wild grapes have been cleared but there still seems to be vines on the fence. Spring 2016.

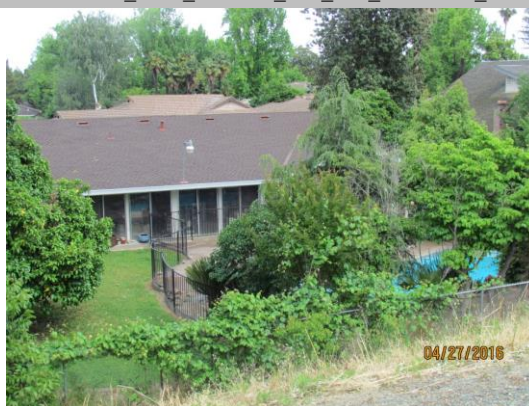
Photo 1 of 1 : SP\_2017\_MA0009\_201\_114\_20170320\_00076.jpg

LM Start	4.31	Rating **	M	Issue No.	114
LM End	4.31	Issue Type +	En	Location *	LS
Category	Earthen Levee			GPS Latitude/Longitude	
				Start	End
Item	Vegetation			38.505294 °	38.505294 °
				-121.556199 °	-121.556199 °
DWR ID	DWR_MA0009_01_s_2012_114				
Comment Code					
V6 : Landscaping					
Inspector Comment					
Trees and vegetation on fence blocks visibility. Trees need to be thinned and trimmed.

View of the fence and landscaping on the landward side of the levee. Spring 2016.

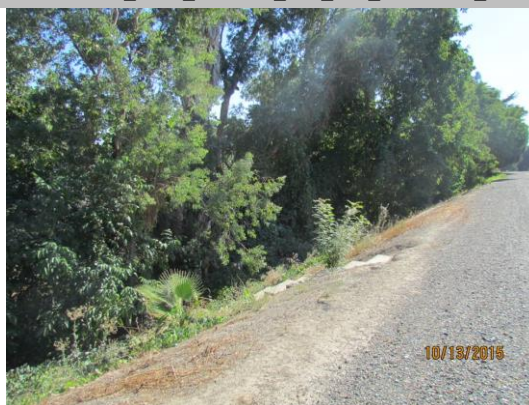
Photo 1 of 2 : SP\_2017\_MA0009\_201\_115\_20170320\_00077.jpg

LM Start	4.33	Rating **	M	Issue No.	115	
LM End	4.33	Issue Type +	En	Location *	LS	
Category	Earthen Levee			GPS Latitude/Longitude		
				Start		End
Item	Vegetation			38.505022 °		38.505022 °
				-121.556283 °		-121.556283 °
DWR ID	DWR_MA0009_01_s_2012_115					
Comment Code						
V6 : Landscaping						
Inspector Comment						
Trees need to be thinned and trimmed for visibility.

Perspective view of the landscaping on the landward side of the levee looking downstream. Fall 2015.

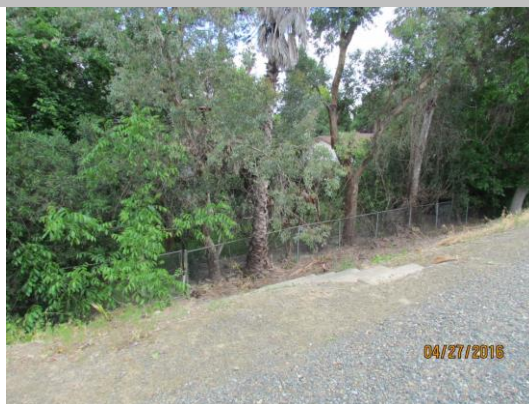
Photo 2 of 2 : SP\_2017\_MA0009\_201\_115\_20170320\_00078.jpg

View of the landscaping at the toe of the levee on the landward side. Spring 2016.

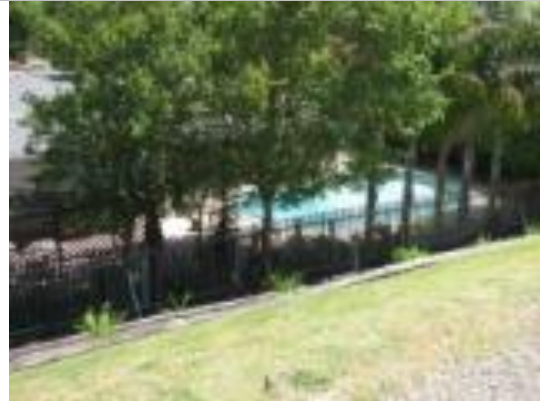
Photo 1 of 1 : SP\_2017\_MA0009\_201\_121\_20170320\_00080.jpg

LM Start	4.45	Rating **	M	Issue No.	121
LM End	4.45	Issue Type +	En	Location *	LS
Category	Earthen Levee			GPS Latitude/Longitude	
				Start	End
Item	Encroachments			38.503350 °	38.503350 °
				-121.556800 °	-121.556800 °
DWR ID	DWR_MA0009_01_s _ 2012_121				
Comment Code					
RW : Retaining Wall					
Inspector Comment

The levee slope has been terraced and with a small retaining wall, fence and landscape. Spring 2013

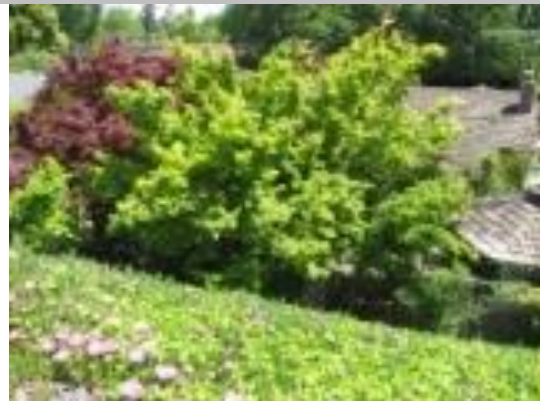
Photo 1 of 1 : SP\_2017\_MA0009\_201\_122\_20170320\_00081.jpg

LM Start	4.46	Rating **	M	Issue No.	122
LM End	4.46	Issue Type +	En	Location *	LS
Category	Earthen Levee			GPS Latitude/Longitude	
				Start	End
Item	Vegetation			38.503106 °	38.503106 °
				-121.556917 °	-121.556917 °
DWR ID	DWR_MA0009_01_s _ 2012_122				
Comment Code					
V6 : Landscaping					
Inspector Comment

Groundcover, fence and landscape makes it hard to see the toe. Spring 2013

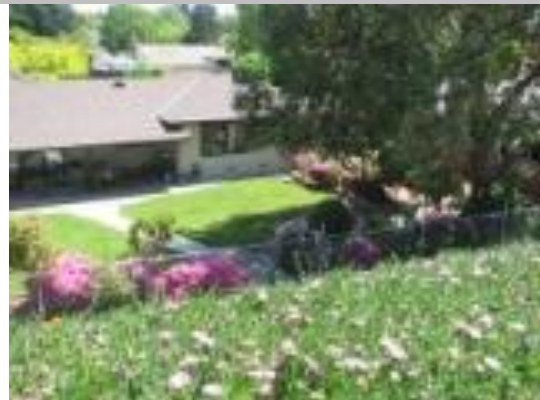
Photo 1 of 1 : SP\_2017\_MA0009\_201\_124\_20170320\_00082.jpg

LM Start	4.48	Rating **	M	Issue No.	124
LM End	4.48	Issue Type +	En	Location *	LS
Category	Earthen Levee			GPS Latitude/Longitude	
				Start	End
Item	Vegetation			38.502861 °	38.502861 °
				-121.557032 °	-121.557032 °
DWR ID	DWR_MA0009_01_s _ 2012_124				
Comment Code					
V6 : Landscaping					
Inspector Comment

Groundcover, fence and landscape. Spring 2013

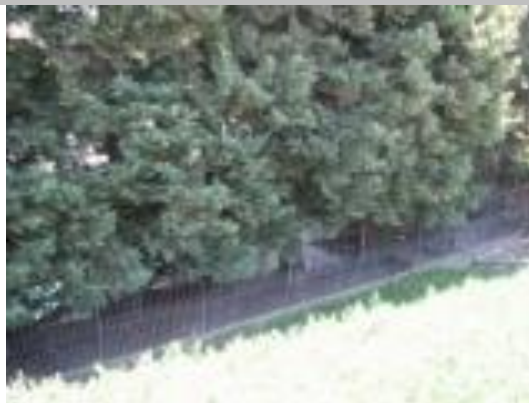
Photo 1 of 1 : SP\_2017\_MA0009\_201\_125\_20170320\_00083.jpg

LM Start	4.50	Rating **	M	Issue No.	125
LM End	4.50	Issue Type +	En	Location *	LS
Category	Earthen Levee			GPS Latitude/Longitude	
				Start	End
Item	Vegetation			38.502669 °	38.502669 °
				-121.557152 °	-121.557152 °
DWR ID	DWR_MA0009_01_s _ 2012_125				
Comment Code					
V6 : Landscaping					
Inspector Comment

Steps, fence and large redwood trees. Spring 2013

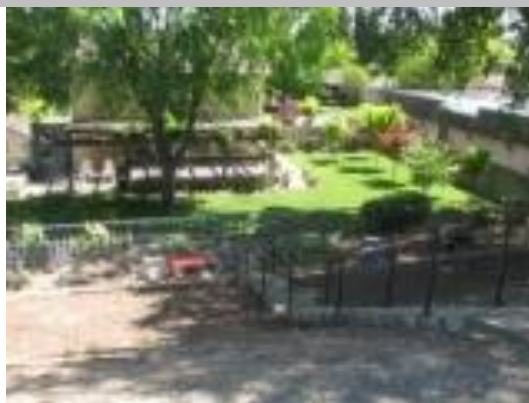
Photo 1 of 1 : SP\_2017\_MA0009\_201\_126\_20170320\_00084.jpg

LM Start	4.52	Rating **	M	Issue No.	126
LM End	4.52	Issue Type +	En	Location *	LS
Category	Earthen Levee			GPS Latitude/Longitude	
				Start	End
Item	Vegetation			38.502401 °	38.502401 °
				-121.557317 °	-121.557317 °
DWR ID	DWR_MA0009_01_s _ 2012_126				
Comment Code					
V6 : Landscaping					
Inspector Comment

Steps with a handrail, fence and landscape. Spring 2013

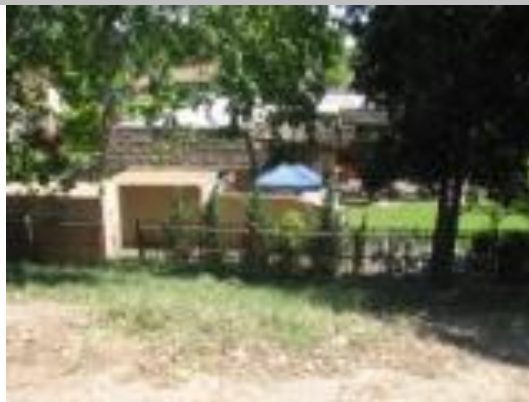
Photo 1 of 1 : SP\_2017\_MA0009\_201\_127\_20170320\_00085.jpg

LM Start	4.54	Rating **	M	Issue No.	127
LM End	4.54	Issue Type +	En	Location *	LS
Category	Earthen Levee			GPS Latitude/Longitude	
				Start	End
Item	Vegetation			38.502163 °	38.502163 °
				-121.557407 °	-121.557407 °
DWR ID	DWR_MA0009_01_s _ 2012_127				
Comment Code					
V6 : Landscaping					
Inspector Comment

Fence, landscape, and buildings at toe. Spring 2013

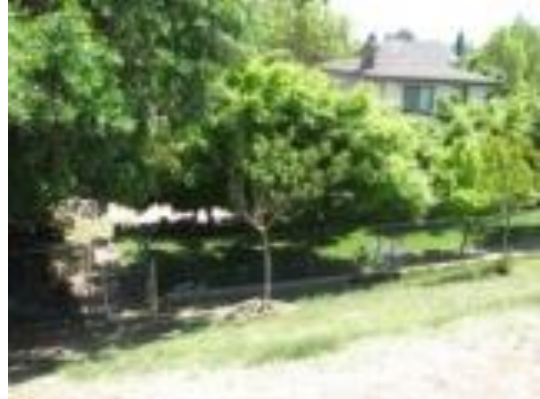
Photo 1 of 1 : SP\_2017\_MA0009\_201\_128\_20170320\_00086.jpg

LM Start	4.55	Rating **	M	Issue No.	128
LM End	4.55	Issue Type +	En	Location *	LS
Category	Earthen Levee			GPS Latitude/Longitude	
				Start	End
Item	Encroachments			38.501895 °	38.501895 °
				-121.557481 °	-121.557481 °
DWR ID	DWR_MA0009_01_s_2012_128				
Comment Code					
RW : Retaining Wall					
Inspector Comment

Trees on the slope, a retaining wall, fence and landscape. Spring 2013

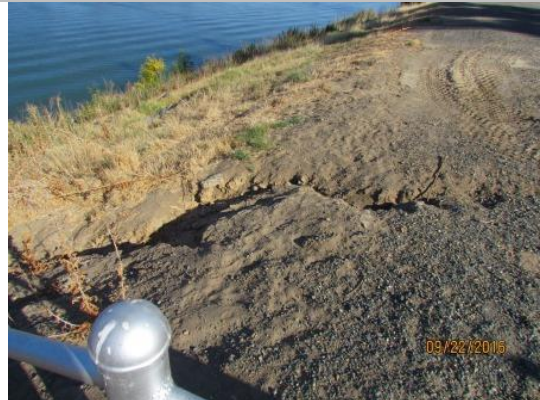
Photo 1 of 4 : SP\_2017\_MA0009\_201\_333\_20170320\_00250.jpg

LM Start	4.59	Rating **	M	Issue No.	333
LM End	4.59	Issue Type +	Ma	Location *	WS
Category	Earthen Levee			GPS Latitude/Longitude	
				Start	End
Item	Erosion / Bank Caving			38.501356 °	38.501356 °
				-121.557638 °	-121.557638 °
DWR ID	DWR_MA0009_01_s_2016_333				
Comment Code					
E2 : Schedule repair of erosion site prior to the next inspection.					
Inspector Comment

Erosion on WS slope. Fall 2016.

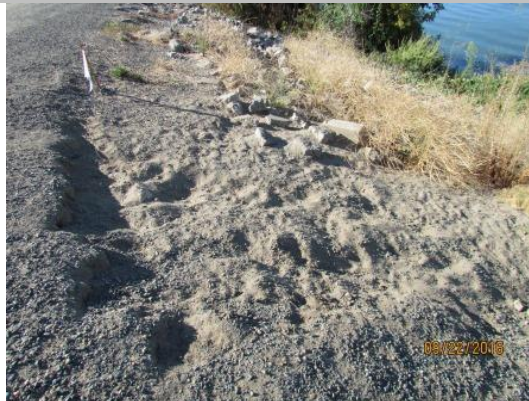
Photo 2 of 4 : SP\_2017\_MA0009\_201\_333\_20170320\_00251.jpg

Another view of erosion on WS slope. Fall 2016.

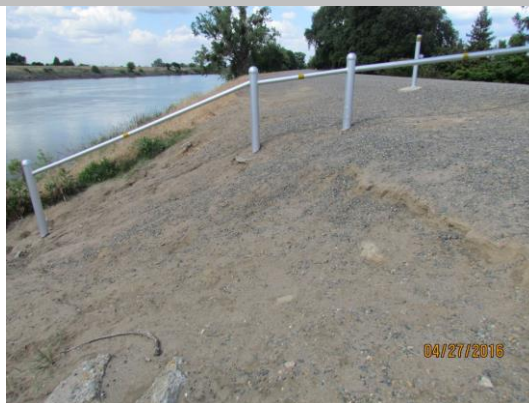
Photo 3 of 4 : SP\_2017\_MA0009\_201\_333\_20170320\_00252.jpg

Perspective view of the erosion site looking upstream. Spring 2016.

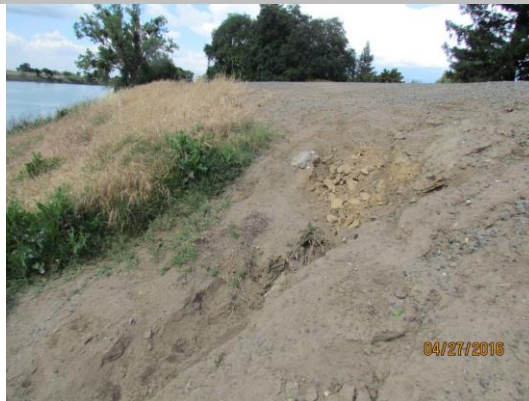
Photo 4 of 4 : SP\_2017\_MA0009\_201\_333\_20170320\_00253.jpg

Erosion is on the waterward slope of the levee. Spring 2016.

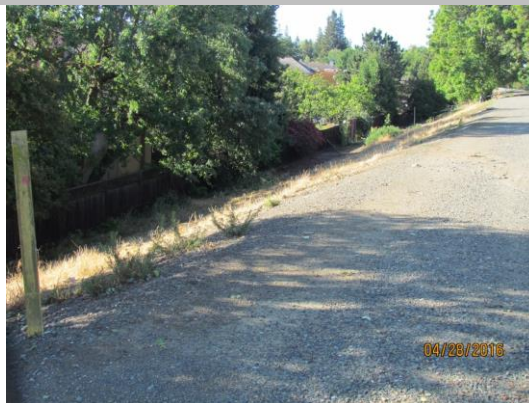
Photo 1 of 1 : SP\_2017\_MA0009\_201\_130\_20170320\_00088.jpg

LM Start	4.65	Rating **	M	Issue No.	130
LM End	4.70	Issue Type +	En	Location *	LS
Category	Earthen Levee			GPS Latitude/Longitude	
				Start	End
Item	Encroachments			38.500565 °	38.499761 °
				-121.557810 °	-121.557832 °
DWR ID	DWR_MA0009_01_s_2012_130				
Comment Code					
FE : Fence					
Inspector Comment

View of the wooden fence under the trees at the toe of the levee on the landward side looking downstream. Spring 2016.

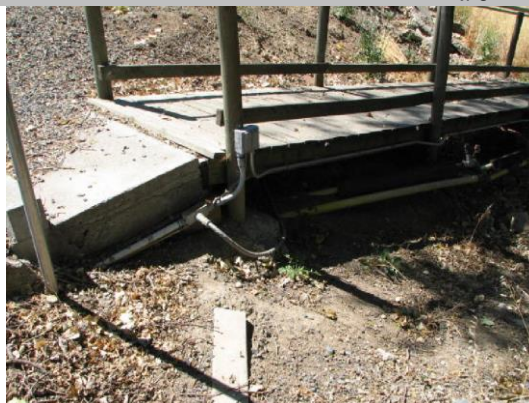
Photo 1 of 3 : UCIP\_SP\_2017\_5760\_8723.jpg

LM Start	4.65	Rating **	M	Issue No.	1790
LM End	4.65	Issue Type +	En	Location *	LS
Category	Supplemental			GPS Latitude/Longitude	
				Start	End
Item	DWR UCIP Field Study			38.500490 °	38.500490 °
				-121.557780 °	-121.557780 °
DWR ID					
Comment Code					
Inspector Comment					
FS_ID:5760 DS_ID:17418 EP_NO: N/A Repair Type: Non-Urgent Crossing Status: Indicator Found UCIP Comments: Locate and determine type of pipe abandonment. FIELD_STRUCT_DESC: *ABANDONED* 8-inch pipe through the levee, 3.4-feet below the crown. Constructed with 1-CM cut-off wall and a pump on the river side. Originally included in the O+M manual (1955). Levee log indicates this pipe abandoned in place. Two t-posts on LS toe may indicate location of pipe. Pictures in Permit 6525 clearly show this pipe just upstream of boat dock walkway. FS Date: 7/25/2012 9:10:00 AM

Boat dock ramp on WS shoulder where pipe may have come through.

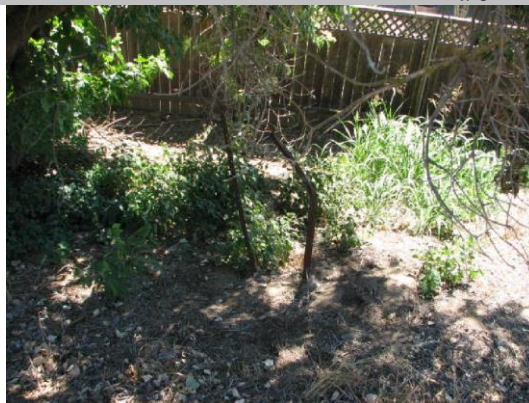
Photo 2 of 3 : UCIP\_SP\_2017\_5760\_8722.jpg

Two t-posts may indicate pipe location on LS slope.

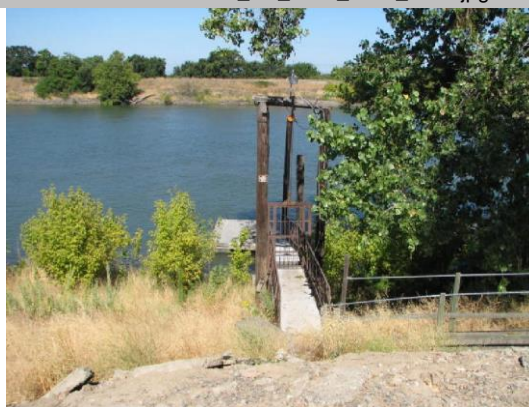
Photo 3 of 3 : UCIP\_SP\_2017\_5760\_8724.jpg

Pier and floating dock near location of pipe.

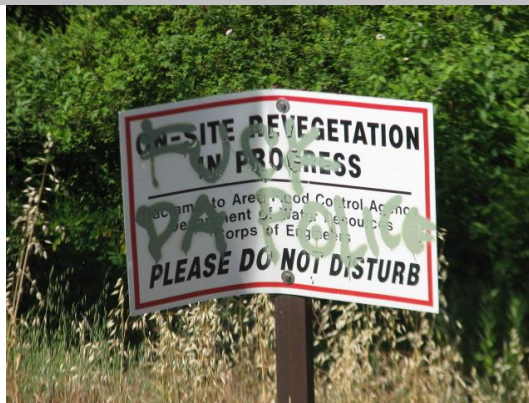
Photo 1 of 1 : SP\_2017\_MA0009\_201\_144\_20170320\_00103.jpg

LM Start	4.67	Rating **	A/W	Issue No.	144
LM End	4.78	Issue Type +	Ob	Location *	WS
Category	Earthen Levee			GPS Latitude/Longitude	
				Start	End
Item	Vegetation			38.500296 °	38.498700 °
				-121.557817 °	-121.557832 °
DWR ID	DWR_MA0009_01_s_2016_144				
Comment Code					
V8 : Environmental Requirements.					
Inspector Comment

Revegetation area on the waterside berm. Spring 2014

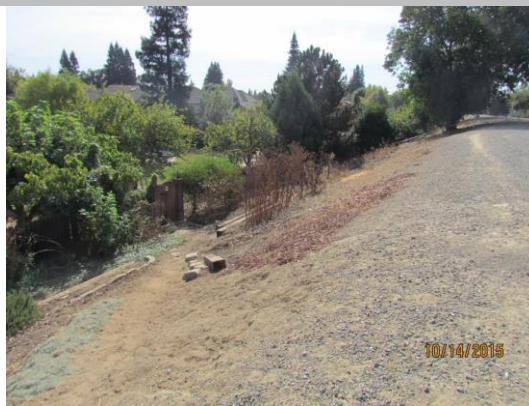
Photo 1 of 2 : SP\_2017\_MA0009\_201\_113\_20170320\_00075.jpg

LM Start	4.68	Rating **	M	Issue No.	113
LM End	4.68	Issue Type +	En	Location *	LS
Category	Earthen Levee			GPS Latitude/Longitude	
				Start	End
Item	Vegetation			38.500062 °	38.500062 °
				-121.557825 °	-121.557825 °
DWR ID	DWR_MA0009_01_s_2012_113				
Comment Code					
V6 : Landscaping					
Inspector Comment

View of the landscaping on the landward side of the levee looking downstream. Fall 2015.

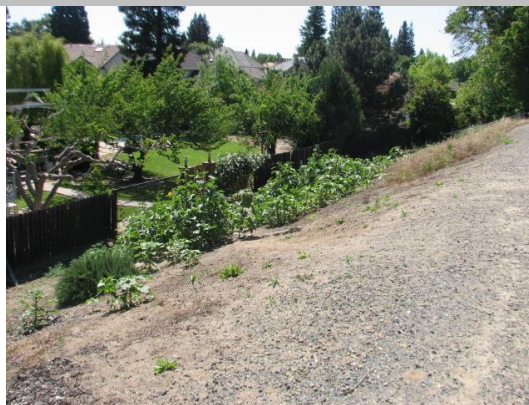
Photo 2 of 2 : SP\_2017\_MA0009\_201\_113\_20170320\_00074.jpg

The garden continues to be on the levee slope. Spring 2014

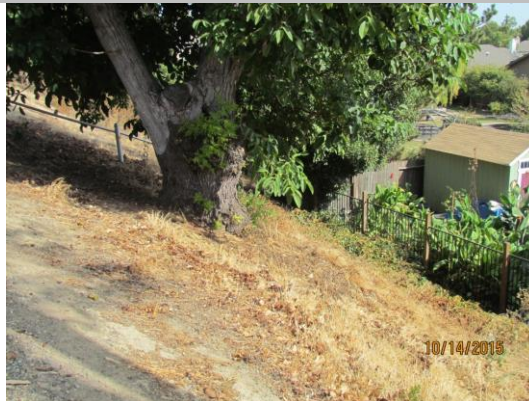
Photo 1 of 1 : SP\_2017\_MA0009\_201\_131\_20170320\_00089.jpg

LM Start	4.71	Rating **	M	Issue No.	131
LM End	4.71	Issue Type +	En	Location *	LS
Category	Earthen Levee			GPS Latitude/Longitude	
				Start	End
Item	Vegetation			38.499636 °	38.499636 °
				-121.557871 °	-121.557871 °
DWR ID	DWR_MA0009_01_s_2012_131				
Comment Code					
V6 : Landscaping					
Inspector Comment

View of the landscaping on the landward side of the levee looking upstream. Blackberry shrubs are at the toe of the levee. Fall 2015.

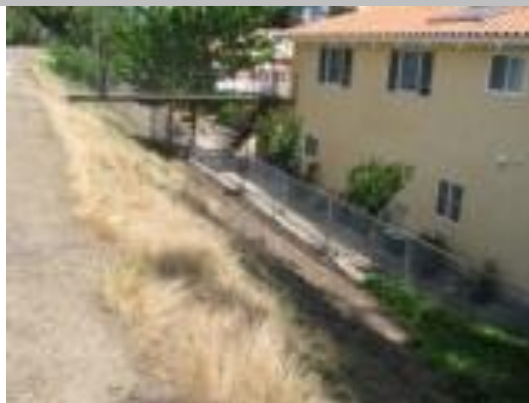
Photo 1 of 2 : SP\_2017\_MA0009\_201\_135\_20170320\_00095.jpg

LM Start	4.96	Rating **	M	Issue No.	135
LM End	4.98	Issue Type +	En	Location *	LS
Category	Earthen Levee			GPS Latitude/Longitude	
				Start	End
Item	Encroachments			38.496110 °	38.495871 °
				-121.556939 °	-121.556777 °
DWR ID	DWR_MA0009_01_s_2012_135				
Comment Code					
RW : Retaining Wall					
Inspector Comment

A retaining wall with a fence on top and some groundcover. Photo taken spring 2012.

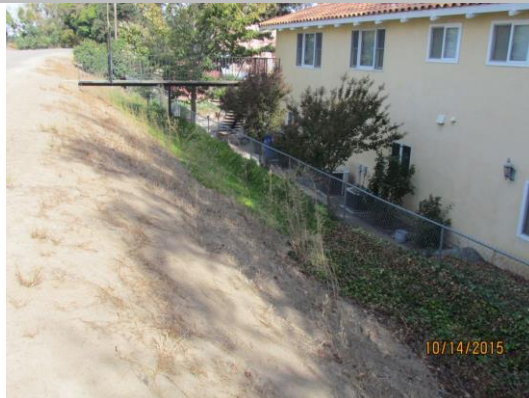
Photo 2 of 2 : SP\_2017\_MA0009\_201\_135\_20170320\_00096.jpg

View of the landscaping on the landward side of the levee looking upstream. The retaining wall has been covered by the groundcover. Fall 2015.

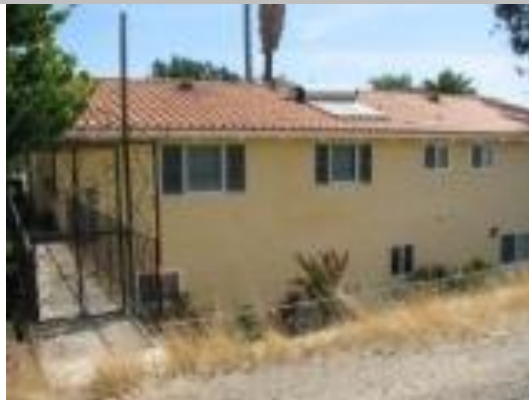
Photo 1 of 1 : SP\_2017\_MA0009\_201\_136\_20170320\_00097.jpg

LM Start	4.97	Rating **	M	Issue No.	136
LM End	4.97	Issue Type +	En	Location *	LS
Category	Earthen Levee			GPS Latitude/Longitude	
				Start	End
Item	Encroachments			38.495981 °	38.495981 °
				-121.556864 °	-121.556864 °
DWR ID	DWR_MA0009_01_s_2012_136				
Comment Code					
BU : Building					
Inspector Comment

The two story house was built at the toe of the levee.

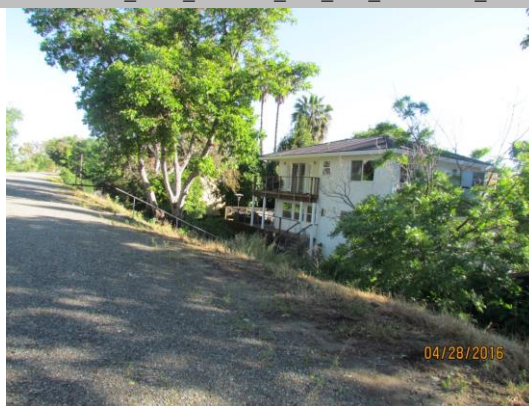
Photo 1 of 1 : SP\_2017\_MA0009\_201\_138\_20170320\_00098.jpg

LM Start	4.99	Rating **	M	Issue No.	138
LM End	4.99	Issue Type +	En	Location *	LS
Category	Earthen Levee			GPS Latitude/Longitude	
				Start	End
Item	Encroachments			38.495687 °	38.495687 °
				-121.556705 °	-121.556705 °
DWR ID	DWR_MA0009_01_s_2012_138				
Comment Code					
BU : Building					
Inspector Comment

View of the house at the toe of the levee on the landward side looking upstream. Spring 2016.

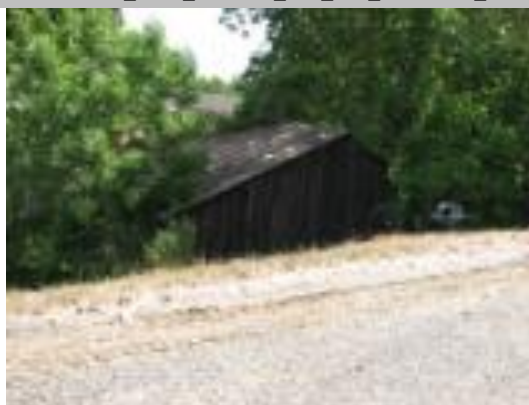
Photo 1 of 2 : SP\_2017\_MA0009\_201\_139\_20170320\_00099.jpg

LM Start	5.01	Rating **	M	Issue No.	139
LM End	5.01	Issue Type +	En	Location *	LS
Category	Earthen Levee			GPS Latitude/Longitude	
				Start	End
Item	Encroachments			38.495529 °	38.495529 °
				-121.556592 °	-121.556592 °
DWR ID	DWR_MA0009_01_s_2012_139				
Comment Code					
BU : Building					
Inspector Comment

The side of the barn is into levee toe.

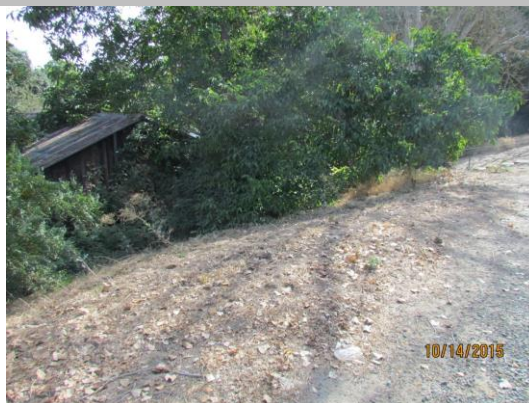
Photo 2 of 2 : SP\_2017\_MA0009\_201\_139\_20170320\_00100.jpg

View of the barn at the levee toe on the landward side of the levee. Trees need to be trimmed for visibility. Fall 2015.

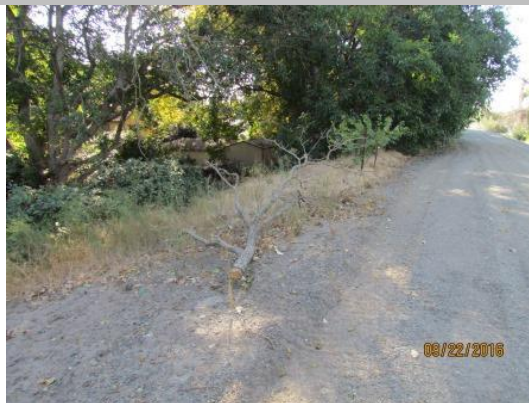
Photo 1 of 1 : SP\_2017\_MA0009\_201\_247\_20170320\_00191.jpg

LM Start	5.02	Rating **	M	Issue No.	247
LM End	5.02	Issue Type +	Ma	Location *	LS
Category	Earthen Levee			GPS Latitude/Longitude	
				Start	End
Item	Encroachments			38.495402 °	38.495402 °
				-121.556507 °	-121.556507 °
DWR ID	DWR_MA0009_01_f_2016_247				
Comment Code					
PR : Prunings					
Inspector Comment

Prunings on LS slope. Fall 2016.

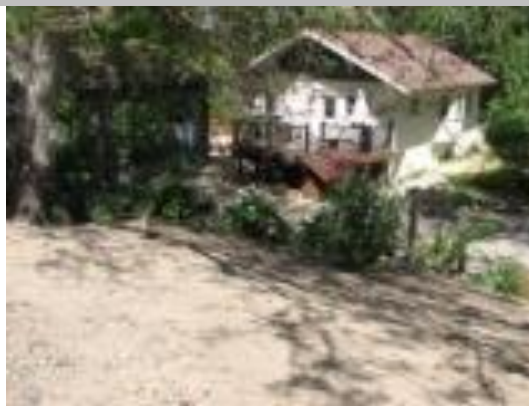
Photo 1 of 2 : SP\_2017\_MA0009\_201\_201\_20170320\_00163.jpg

LM Start	5.02	Rating **	M	Issue No.	201
LM End	5.02	Issue Type +	En	Location *	LS
Category	Earthen Levee			GPS Latitude/Longitude	
				Start	End
Item	Vegetation			38.495400 °	38.495400 °
				-121.556488 °	-121.556488 °
DWR ID	DWR_MA0009_01_s_2013_201				
Comment Code					
V6 : Landscaping					
Inspector Comment

Shrubs and small trees are being planted on the levee. Spring 2013

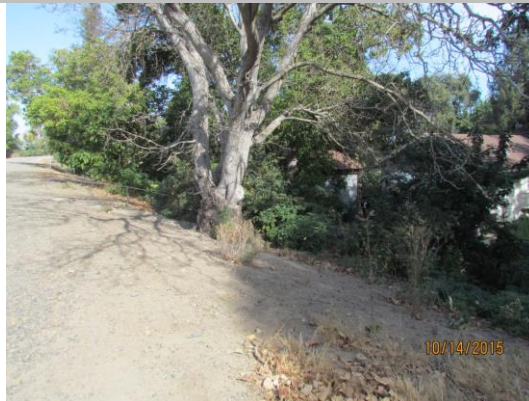
Photo 2 of 2 : SP\_2017\_MA0009\_201\_201\_20170320\_00164.jpg

View of the landscaping at the toe of the levee on the landward side looking upstream. Fall 2015.

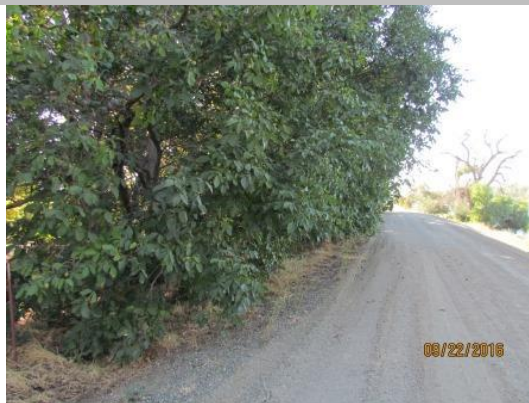
Photo 1 of 2 : SP\_2017\_MA0009\_201\_328\_20170320\_00247.jpg

LM Start	5.03	Rating **	M	Issue No.	328
LM End	5.07	Issue Type +	En	Location *	LS
Category	Earthen Levee			GPS Latitude/Longitude	
				Start	End
Item	Vegetation			38.495235 °	38.494701 °
				-121.556393 °	-121.556022 °
DWR ID	DWR_MA0009_01_f_2015_328				
Comment Code					
V6 : Landscaping					
Inspector Comment

Trees still need trimming. Fall 2016.

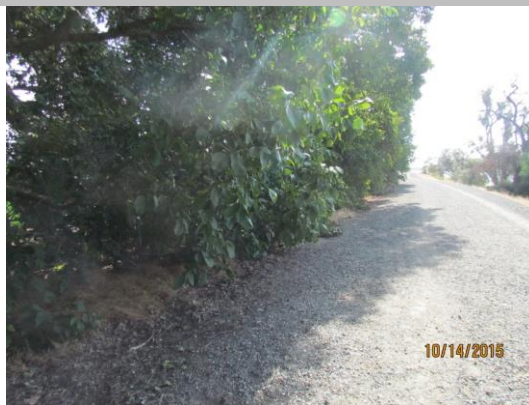
Photo 2 of 2 : SP\_2017\_MA0009\_201\_328\_20170320\_00248.jpg

View of the trees on the landward side of the levee looking downstream. Trees need to be trimmed. Fall 2015.

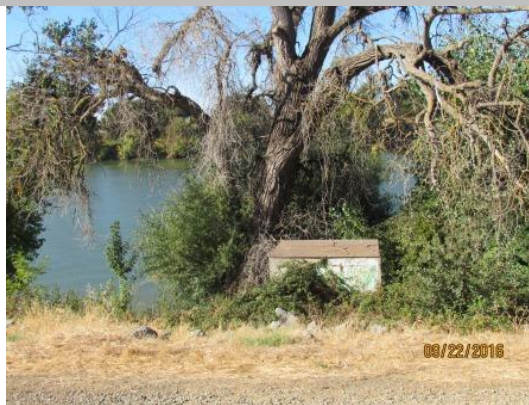
Photo 1 of 1 : SP\_2017\_MA0009\_201\_248\_20170320\_00192.jpg

LM Start	5.08	Rating **	M	Issue No.	248
LM End	5.08	Issue Type +	En	Location *	WS
Category	Earthen Levee			GPS Latitude/Longitude	
				Start	End
Item	Encroachments			38.494647 °	38.494647 °
				-121.555962 °	-121.555962 °
DWR ID	DWR_MA0009_01_f_2016_248				
Comment Code					
BU : Building					
Inspector Comment					
Abandoned pump house on waterward slope. Was recorded in levee log w/o permit number.

View of a pump house on WS slope. Fall 2016.

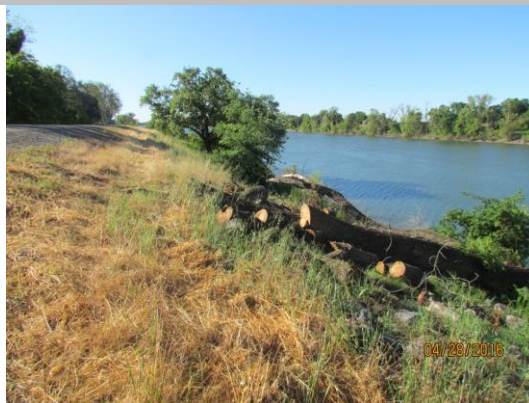
Photo 1 of 1 : SP\_2017\_MA0009\_201\_336\_20170320\_00256.jpg

LM Start	5.08	Rating **	M	Issue No.	336
LM End	5.08	Issue Type +	Ma	Location *	WS
Category	Earthen Levee			GPS Latitude/Longitude	
				Start	End
Item	Encroachments			38.494527 °	38.494527 °
				-121.555889 °	-121.555889 °
DWR ID	DWR_MA0009_01_s_2016_336				
Comment Code					
TR : Tree or limb					
Inspector Comment

View of the fallen tree on the waterward slope looking downstream. Spring 2016.

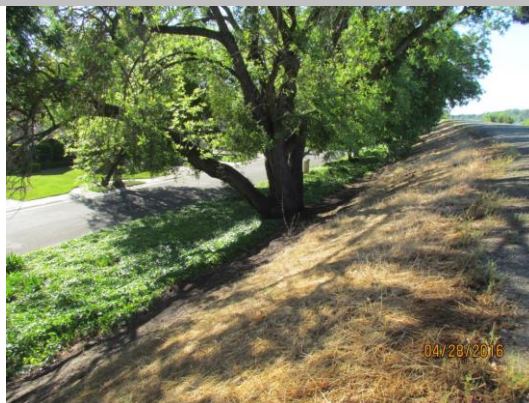
Photo 1 of 1 : SP\_2017\_MA0009\_201\_141\_20170320\_00101.jpg

LM Start	5.09	Rating **	M	Issue No.	141
LM End	5.17	Issue Type +	En	Location *	LS
Category	Earthen Levee			GPS Latitude/Longitude	
				Start	End
Item	Vegetation			38.494477 °	38.493431 °
				-121.555809 °	-121.555082 °
DWR ID	DWR_MA0009_01_s_2012_141				
Comment Code					
V6 : Landscaping					
Inspector Comment

View of the groundcover planted on the berm on the landward side of the levee looking downstream. Spring 2016.

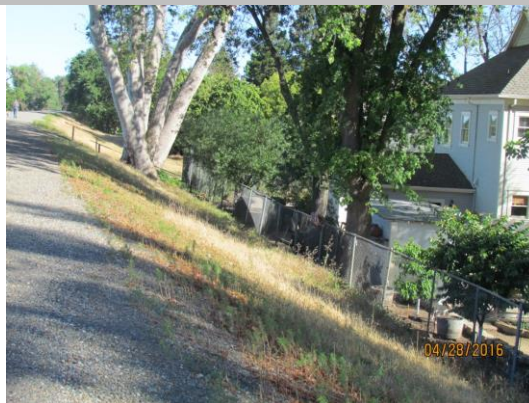
Photo 1 of 1 : SP\_2017\_MA0009\_201\_143\_20170320\_00102.jpg

LM Start	5.24	Rating **	M	Issue No.	143
LM End	5.28	Issue Type +	En	Location *	LS
Category	Earthen Levee			GPS Latitude/Longitude	
				Start	End
Item	Vegetation			38.492574 °	38.492131 °
				-121.554423 °	-121.554072 °
DWR ID	DWR_MA0009_01_s_2012_143				
Comment Code					
V6 : Landscaping					
Inspector Comment

View of the landscaping at the toe of the levee on the landward side looking upstream. Spring 2016.

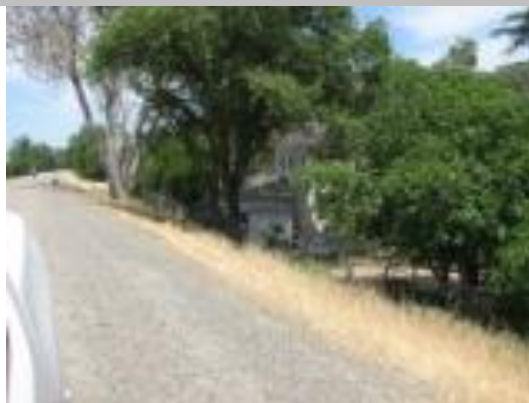
Photo 1 of 2 : SP\_2017\_MA0009\_201\_145\_20170320\_00104.jpg

LM Start	5.25	Rating **	M	Issue No.	145
LM End	5.25	Issue Type +	En	Location *	LS
Category	Earthen Levee			GPS Latitude/Longitude	
				Start	End
Item	Encroachments			38.492442 °	38.492442 °
				-121.554319 °	-121.554319 °
DWR ID	DWR_MA0009_01_s_2012_145				
Comment Code					
BU : Building					
Inspector Comment

The building encroaches into the levee.

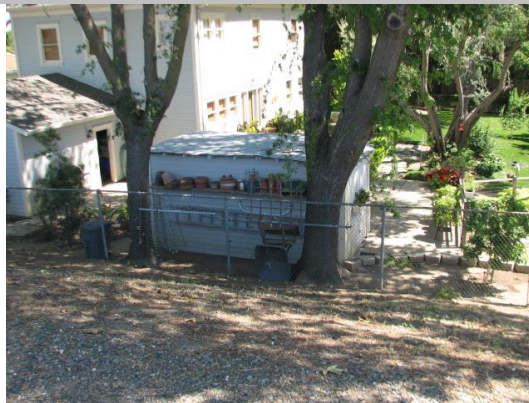
Photo 2 of 2 : SP\_2017\_MA0009\_201\_145\_20170320\_00105.jpg

A garden shed at the toe of the levee. Spring 2014

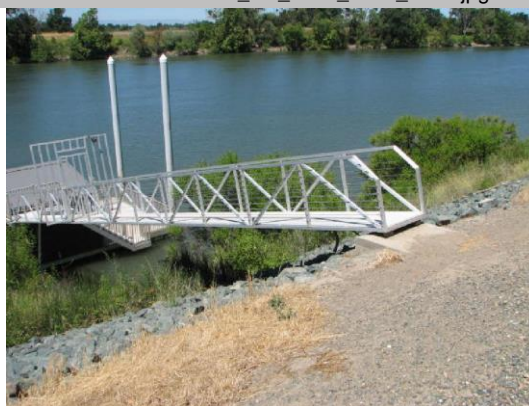
Photo 2 of 2 : UCIP\_SP\_2017\_5900\_8961.jpg

LM Start	5.31	Rating **	M	Issue No.	1791 (cont)
LM End	5.31	Issue Type +	En	Location *	LS
Category	Supplemental			GPS Latitude/Longitude	
				Start	End
Item	DWR UCIP Field Study			38.491750 °	38.491750 °
				-121.553730 °	-121.553730 °
DWR ID					
Comment Code					
Inspector Comment					
FS_ID:5900 DS_ID:18943 EP_NO: 12922 Repair Type: Non-Urgent Crossing Status: Found UCIP Comments: No permit identified for this crossing. FIELD_STRUCT_DESC: 1 of 2: 2-inch electrical conduit through the levee at an undetermined depth on downstream side of boat dock ramp. FS Date: 6/20/2012 2:20:30 PM

Ramp at WS shoulder.

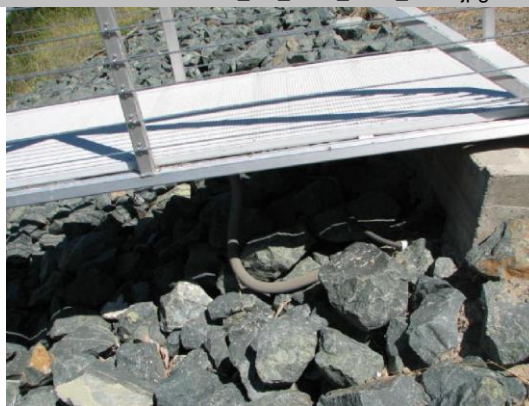
Photo 1 of 2 : UCIP\_SP\_2017\_5901\_8964.jpg

LM Start	5.31	Rating **	M	Issue No.	1792
LM End	5.31	Issue Type +	En	Location *	LS
Category	Supplemental			GPS Latitude/Longitude	
				Start	End
Item	DWR UCIP Field Study			38.491730 °	38.491730 °
				-121.553720 °	-121.553720 °
DWR ID					
Comment Code					
Inspector Comment					
FS_ID:5901 DS_ID:18944 EP_NO: 12922 Repair Type: Non-Urgent Crossing Status: Found UCIP Comments: No permit identified for this crossing. FIELD_STRUCT_DESC: 2 of 2: 2-inch water line through the levee at an undetermined depth on downstream side of boat dock ramp. FS Date: 6/20/2012 2:40:41 PM

Pipes through levee under walkway on WS shoulder.

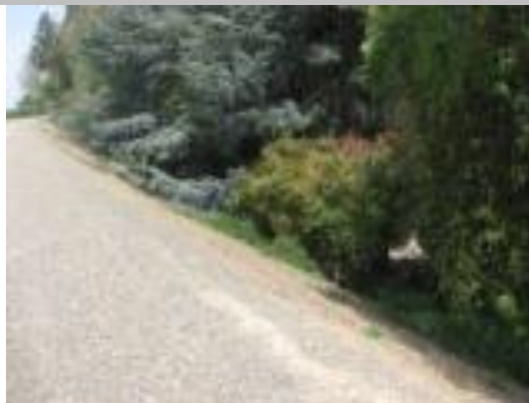
Photo 1 of 2 : SP\_2017\_MA0009\_201\_148\_20170320\_00107.jpg

LM Start	5.34	Rating **	U	Issue No.	148
LM End	5.38	Issue Type +	En	Location *	LS
Category	Earthen Levee			GPS Latitude/Longitude	
				Start	End
Item	Vegetation			38.491357 °	38.490897 °
				-121.553393 °	-121.552974 °
DWR ID	DWR_MA0009_01_s_2012_148				
Comment Code					
V6 : Landscaping					
Inspector Comment					
Landscaping blocks visibility of levee slopes.

The cedar tree covers the levee slope blocks visibility. Photo taken spring 2012.

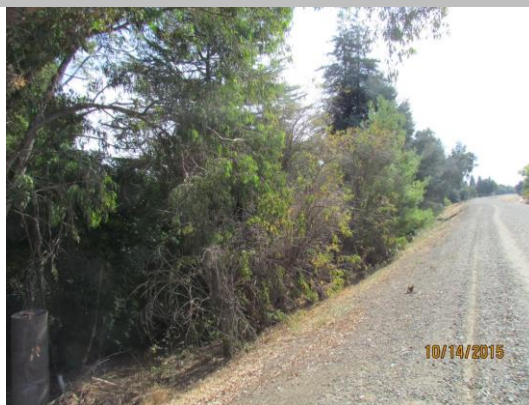
Photo 2 of 2 : SP\_2017\_MA0009\_201\_148\_20170320\_00108.jpg

View of the landscaping along the levee slope on the landward side looking downstream. Fall 2015.

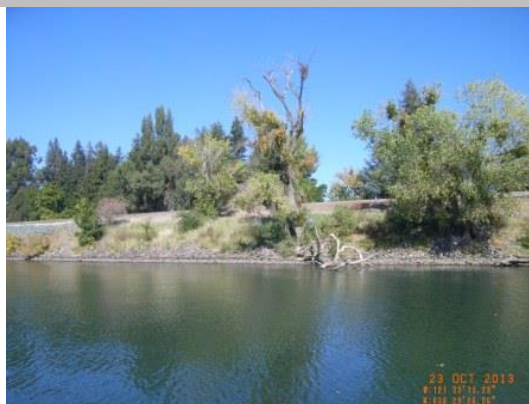
Photo 1 of 1 : SP\_2017\_MA0009\_201\_16\_20170320\_00018.jpg

LM Start	5.35	Rating **	M	Issue No.	16
LM End	5.37	Issue Type +	Ma	Location *	WS
Category	Supplemental			GPS Latitude/Longitude	
				Start	End
Item	2015 USACE Erosion Survey, DRAFT			38.491086 °	38.490892 °
				-121.553540 °	-121.553352 °
DWR ID	DWR_MA0009_01_s_2016_16				
Comment Code					
Inspector Comment					
2011 - Tree popout at the toe has taken out the rock toe protection. 2015: No observed changes. [2015 Site ID: SAC_50-3_L]

USACE 2013 Photo #1

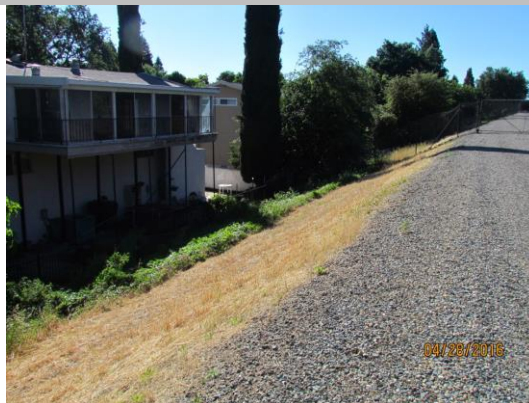
Photo 1 of 1 : SP\_2017\_MA0009\_201\_149\_20170320\_00109.jpg

LM Start	5.44	Rating **	M	Issue No.	149
LM End	5.46	Issue Type +	En	Location *	LS
Category	Earthen Levee			GPS Latitude/Longitude	
				Start	End
Item	Vegetation			38.490197 °	38.490023 °
				-121.552327 °	-121.552153 °
DWR ID	DWR_MA0009_01_s_2012_149				
Comment Code					
V6 : Landscaping					
Inspector Comment

View of the landscaping at the toe of the levee on the landward side looking downstream. Spring 2016.

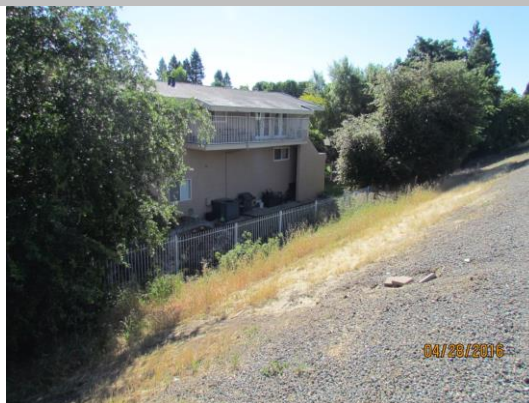
Photo 1 of 1 : SP\_2017\_MA0009\_201\_150\_20170320\_00110.jpg

LM Start	5.46	Rating **	M	Issue No.	150
LM End	5.47	Issue Type +	En	Location *	LS
Category	Earthen Levee			GPS Latitude/Longitude	
				Start	End
Item	Encroachments			38.489974 °	38.489807 °
				-121.552121 °	-121.551990 °
DWR ID	DWR_MA0009_01_s_2012_150				
Comment Code					
FE : Fence					
Inspector Comment

View of the fence and landscaping at the toe of the levee looking downstream. Spring 2016.

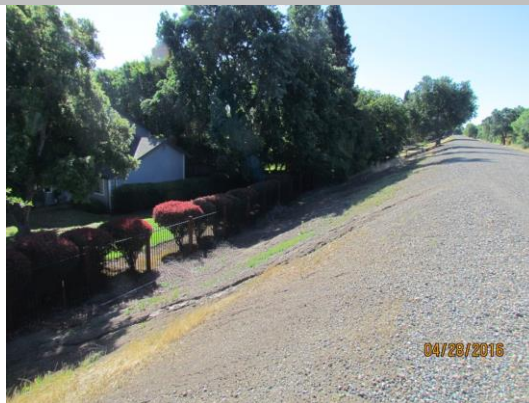
Photo 1 of 1 : SP\_2017\_MA0009\_201\_151\_20170320\_00111.jpg

LM Start	5.48	Rating **	M	Issue No.	151
LM End	5.50	Issue Type +	En	Location *	LS
Category	Earthen Levee			GPS Latitude/Longitude	
				Start	End
Item	Vegetation			38.489730 °	38.489503 °
				-121.551924 °	-121.551748 °
DWR ID	DWR_MA0009_01_s_2012_151				
Comment Code					
V6 : Landscaping					
Inspector Comment

View of the pruned shrubs at the toe of the levee on the landward side looking downstream. Spring 2016.

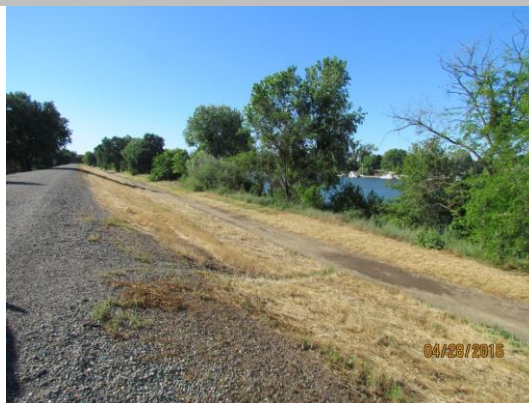
Photo 1 of 2 : SP\_2017\_MA0009\_201\_132\_20170320\_00090.jpg

LM Start	5.49	Rating **	A/W	Issue No.	132
LM End	5.93	Issue Type +	En	Location *	WS
Category	Earthen Levee			GPS Latitude/Longitude	
				Start	End
Item	Vegetation			38.489589 °	38.484026 °
				-121.551825 °	-121.547831 °
DWR ID	DWR_MA0009_01_s_2012_132				
Comment Code					
V8 : Environmental Requirements.					
Inspector Comment

View of the revegetation site on the waterward berm of the levee looking downstream. Spring 2016.

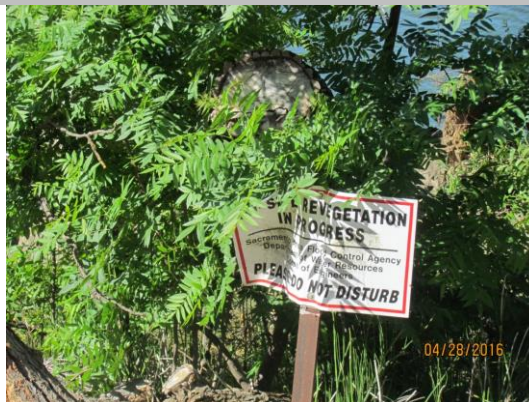
Photo 2 of 2 : SP\_2017\_MA0009\_201\_132\_20170320\_00091.jpg

Sign stating the revegetation site. Spring 2016.

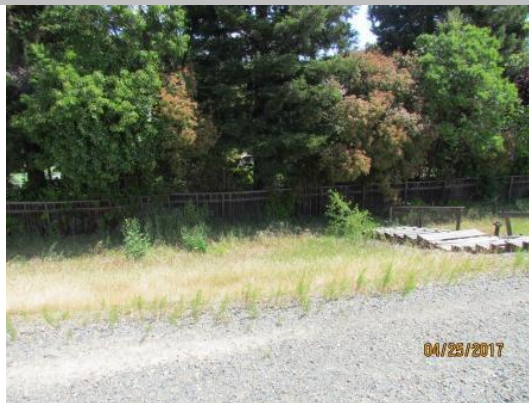
Photo 1 of 2 : SP\_2017\_MA0009\_201\_152\_20170426\_00505.jpg

LM Start	5.50	Rating **	U	Issue No.	152
LM End	5.53	Issue Type +	En	Location *	LS
Category	Earthen Levee			GPS Latitude/Longitude	
				Start	End
Item	Encroachments			38.489476 °	38.489125 °
				-121.551736 °	-121.551466 °
DWR ID	DWR_MA0009_01_s_2012_152				
Comment Code					
FE : Fence					
Inspector Comment

View of fence at landside levee toe. Spring 2017.

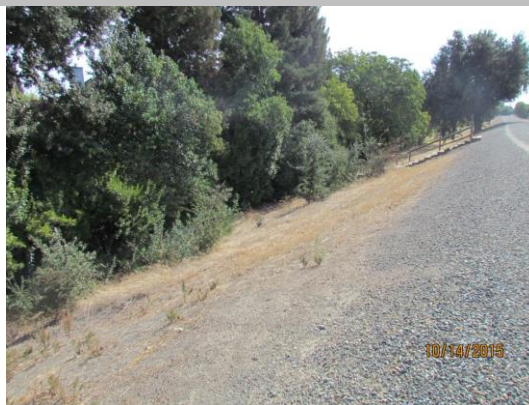
Photo 2 of 2 : SP\_2017\_MA0009\_201\_152\_20170320\_00112.jpg

View of the landscaping at the toe of the levee on the landward side looking downstream. Fall 2015.

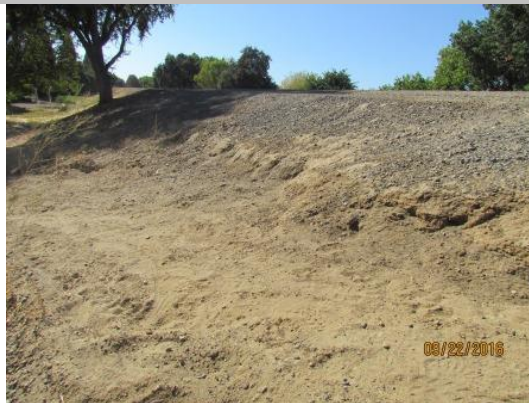
Photo 1 of 2 : SP\_2017\_MA0009\_201\_358\_20170320\_00271.jpg

LM Start	5.52	Rating **	M	Issue No.	358
LM End	5.52	Issue Type +	Ma	Location *	LS
Category	Earthen Levee			GPS Latitude/Longitude	
				Start	End
Item	Slope Stability			38.489181 °	38.489181 °
				-121.551510 °	-121.551510 °
DWR ID	DWR_MA0009_01_s_2016_358				
Comment Code					
S2 : Repair the levee slope damaged by foot traffic and prevent access where possible.					
Inspector Comment

View of the site on LS of the levee looking downstream. Fall 2016.

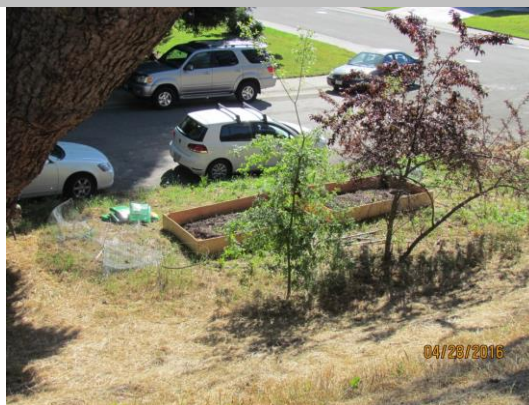
Photo 1 of 2 : SP\_2017\_MA0009\_201\_367\_20170320\_00284.jpg

LM Start	<b>5.83</b>	Rating **	M	Issue No.	<b>367 (cont)</b>
LM End	<b>5.83</b>	Issue Type +	En	Location *	LS

A garden is on the berm of the levee on the landward side. Spring 2016.

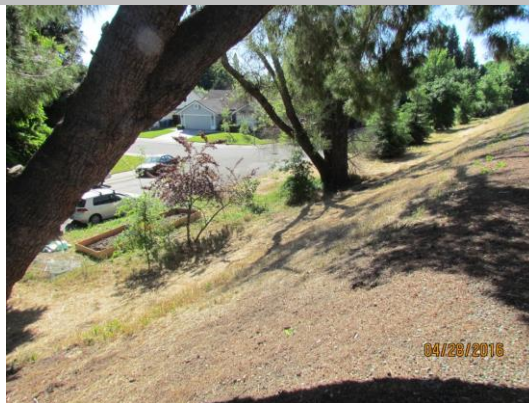
Photo 2 of 2 : SP\_2017\_MA0009\_201\_367\_20170320\_00285.jpg

View of the garden looking downstream. Spring 2016.

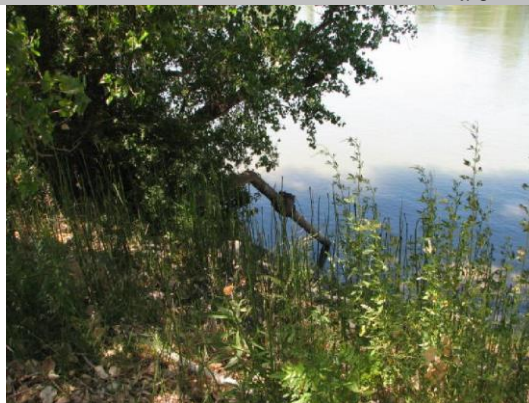
Photo 1 of 3 : UCIP\_SP\_2017\_4980\_6630.jpg

LM Start	5.93	Rating **	M	Issue No.	1793
LM End	5.93	Issue Type +	En	Location *	LS
Category	Supplemental			GPS Latitude/Longitude	
				Start	End
Item	DWR UCIP Field Study			38.484130 °	38.484130 °
				-121.547854 °	-121.547854 °
DWR ID					
Comment Code					
Inspector Comment					
FS_ID:4980 DS_ID:17425 EP_NO: N/A Repair Type: Non-Urgent Crossing Status: Found UCIP Comments: Pipe has holes at welds on WS near bend in pipe. This pipe appears to be abandoned so it may need to be removed or grouted in place. FIELD_STRUCT_DESC: 8-inch concrete encased pipe through the levee, 4.9 feet below the crown. Pump in pump house on waterward slope, Siphon breaker in C.M riser on landward slope have been removed. Originally included in O+M manual (1955). FS Date: 6/20/2012 12:55:36 PM

Pipe entering water at WS toe

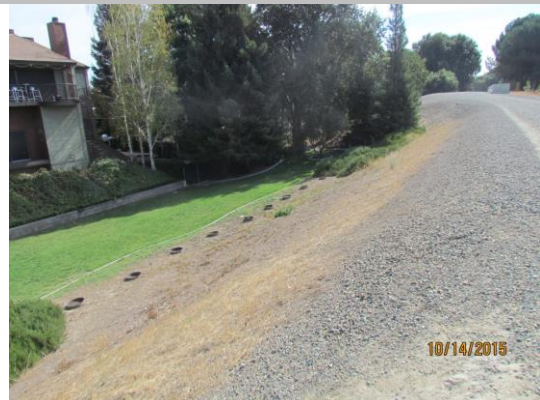
Photo 1 of 1 : SP\_2017\_MA0009\_201\_155\_20170320\_00115.jpg

LM Start	5.96	Rating **	M	Issue No.	155
LM End	5.99	Issue Type +	En	Location *	LS
Category	Earthen Levee			GPS Latitude/Longitude	
				Start	End
Item	Vegetation			38.483639 °	38.483310 °
				-121.547532 °	-121.547297 °
DWR ID	DWR_MA0009_01_s_2012_155				
Comment Code					
V6 : Landscaping					
Inspector Comment

View of the garden on the landward side of the levee looking downhill. Fall 2015.

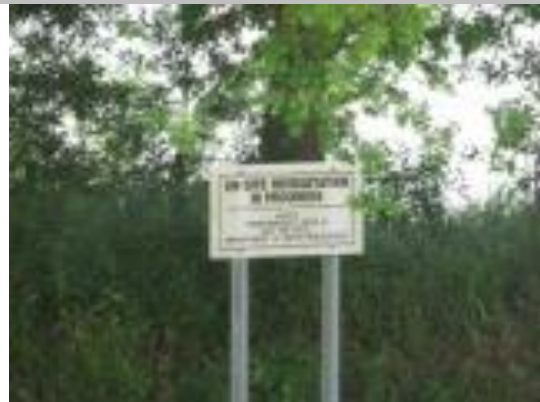
Photo 1 of 2 : SP\_2017\_MA0009\_201\_134\_20170320\_00093.jpg

LM Start	6.13	Rating **	A/W	Issue No.	134
LM End	6.25	Issue Type +	En	Location *	WS
Category	Earthen Levee			GPS Latitude/Longitude	
				Start	End
Item	Vegetation			38.481560 °	38.480129 °
				-121.545850 °	-121.544858 °
DWR ID	DWR_MA0009_01_s _ 2012_134				
Comment Code					
V8 : Environmental Requirements.					
Inspector Comment

A revegetation site. Photo taken spring 2012.

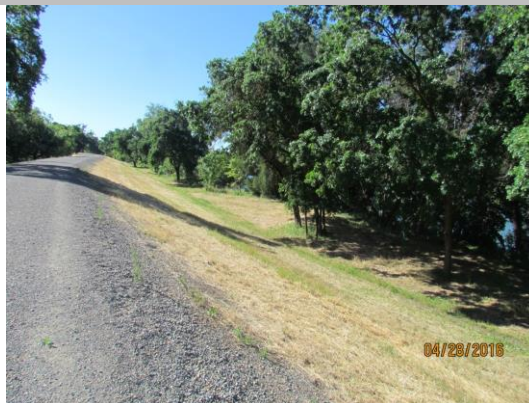
Photo 2 of 2 : SP\_2017\_MA0009\_201\_134\_20170320\_00094.jpg

LM Start	6.13	Rating **	A/W	Issue No.	134 (cont)	
LM End	6.25	Issue Type +	En	Location *	WS	
Category	Earthen Levee			GPS Latitude/Longitude		
				Start		End
Item	Vegetation			38.481560 °		38.480129 °
				-121.545850 °		-121.544858 °
DWR ID	DWR_MA0009_01_s_2012_134					
Comment Code						
V8 : Environmental Requirements.						
Inspector Comment

View of the revegetation site on the berm of the waterward side of the levee looking downstream. Spring 2016.
